## WELL HOUSE CONSERVATION MANAGEMENT REPORT

DAVID KELLY PARTNERSHIP  
MARGARET QUINLAN ARCHITECTS

Funded by  
  **An Chomhairle Oidhreachta**  
**The Heritage Council**  
(Grant Ref. No. CH18160)

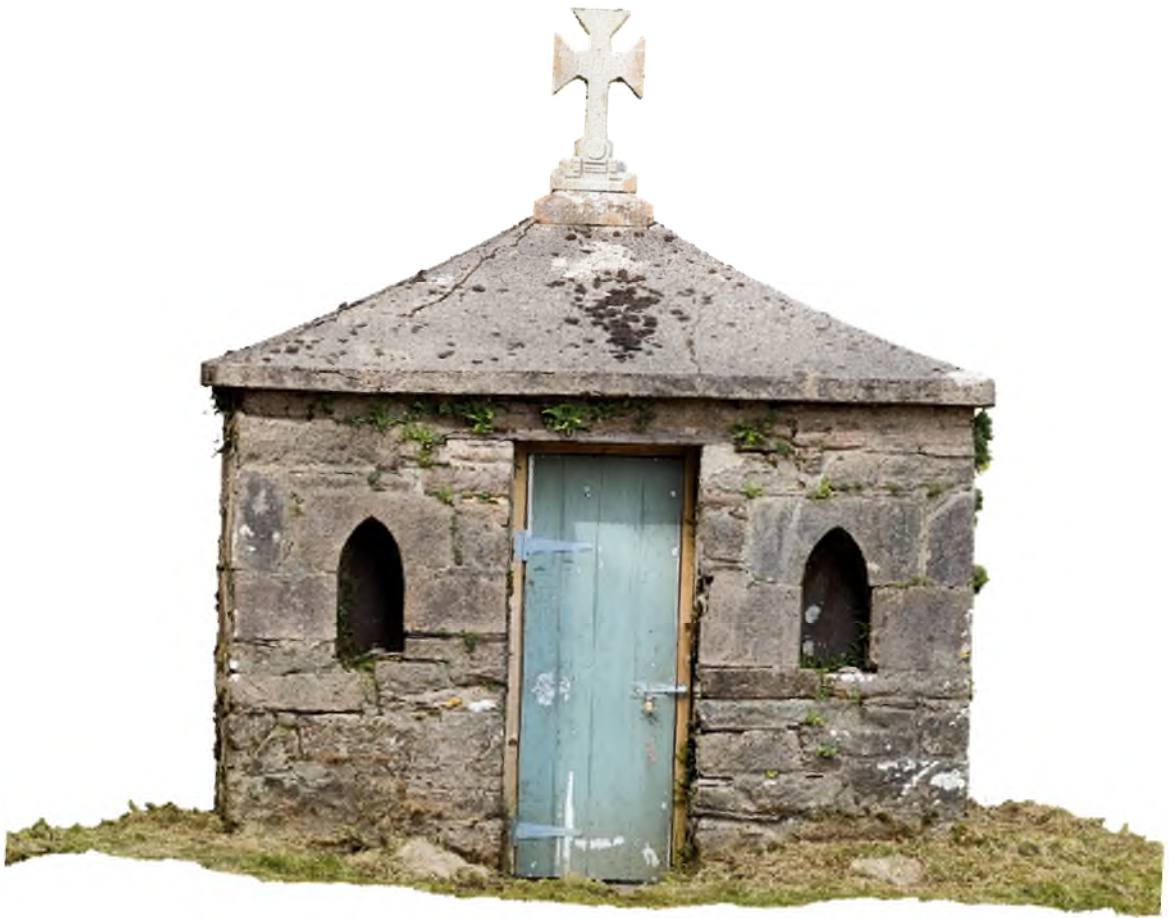
**South Elevation - External**

The roof slope comprises smooth concrete with a slightly sprocketed profile and a short overhang at the eaves. There is one wide crack close to the western hip and narrower cracks on the eastern side, all emanating from the base of the stone cross at the apex of the roof.

The roughly coursed sandstone masonry wall contains two small arch headed niches backed by slate, one either side of the timber sheeted door which has an unpainted timber lintel at its head. There is light vegetation growing from the joints. The masonry joints are quite thin, and the mortar joints are somewhat eroded. There is horizontal cracking just under the eaves course at the external corners.

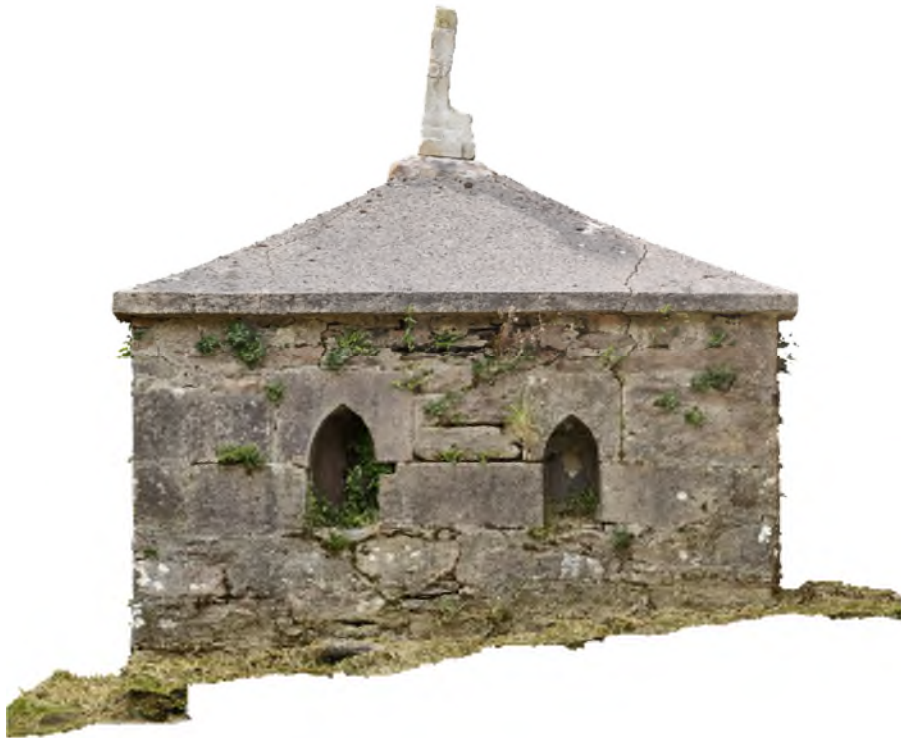
**East Elevation - External**

The roof slope comprises smooth concrete with a short overhang at the eaves. There are two significant cracks close to the hips, north and south. The northern crack extends through the wall masonry.

The roughly coursed sandstone masonry wall contains two small arch headed niches backed by slate. There is light vegetation growing from the joints. The masonry joints are quite eroded, particularly in the centre of the elevation.

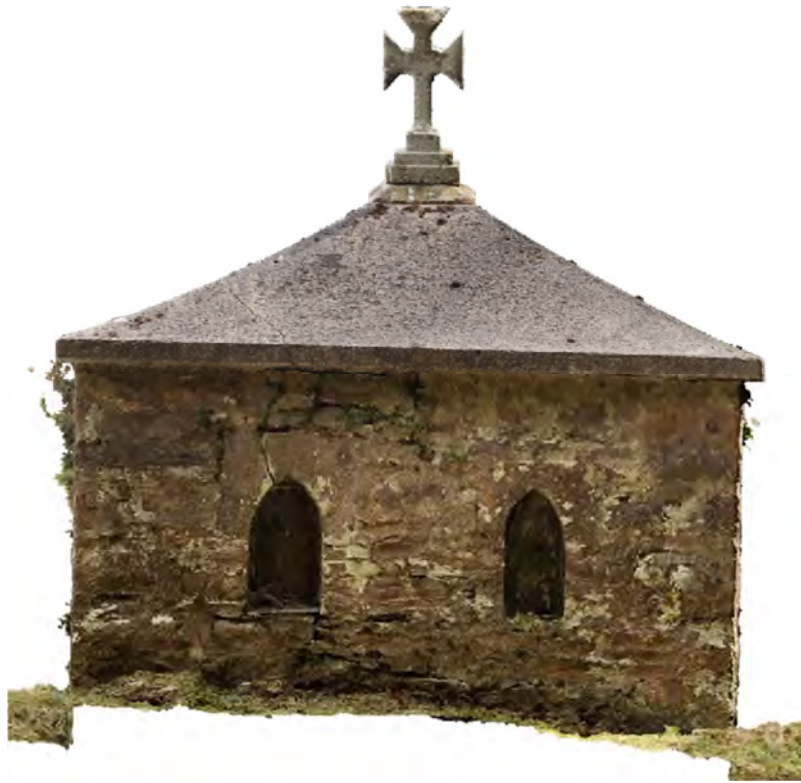
**North Elevation - External**

The roof slope comprises smooth concrete with a short overhang at the eaves. There is a significant crack across the hip at the eastern side which extends through the wall masonry and has cracked the arch-headed lintel (formed from a single piece of stone) over the eastern niche.

The random rubble sandstone masonry wall contains two small arch headed niches with dressed sandstone heads and backed by slate. There is light vegetation growing from the joints. The masonry joints are quite eroded, particularly over the eastern niche and at the base of the wall.

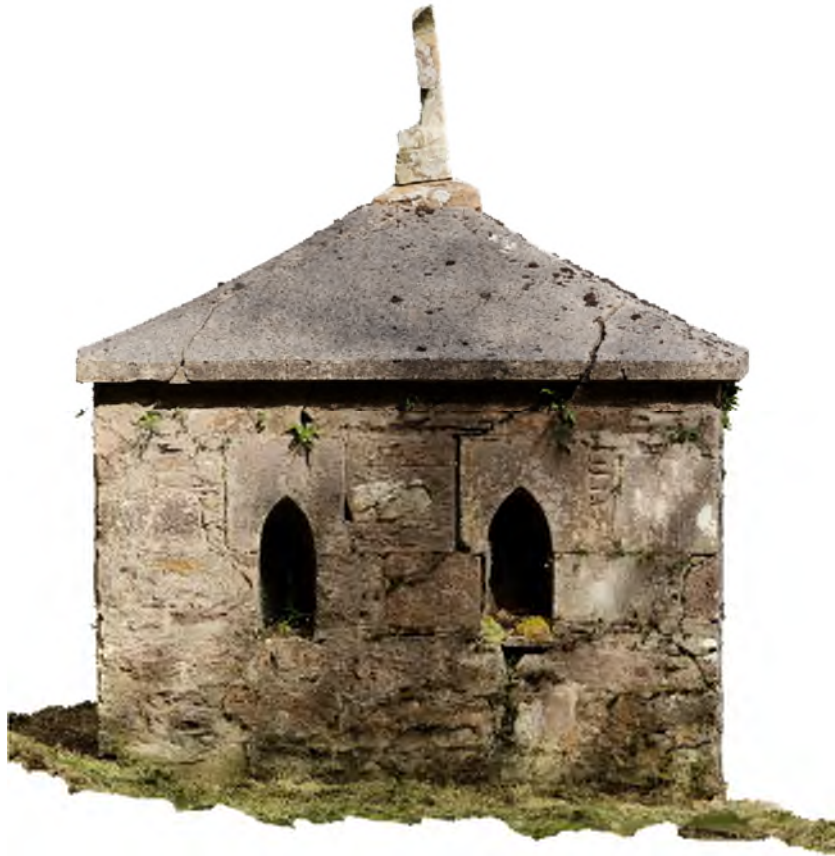
**West Elevation - External**

The roof slope comprises smooth concrete with a short overhang at the eaves. There are two significant cracks close to the hips, north and south. The northern crack extends through the eaves, detaching a small piece. The southern crack is much wider and extends through the wall masonry, around the dressed stone arch-headed lintel.

The roughly coursed sandstone masonry wall contains two small arch headed niches backed by slate. There is light vegetation growing from the joints. There are further cracks in the wall masonry at the southern corner.

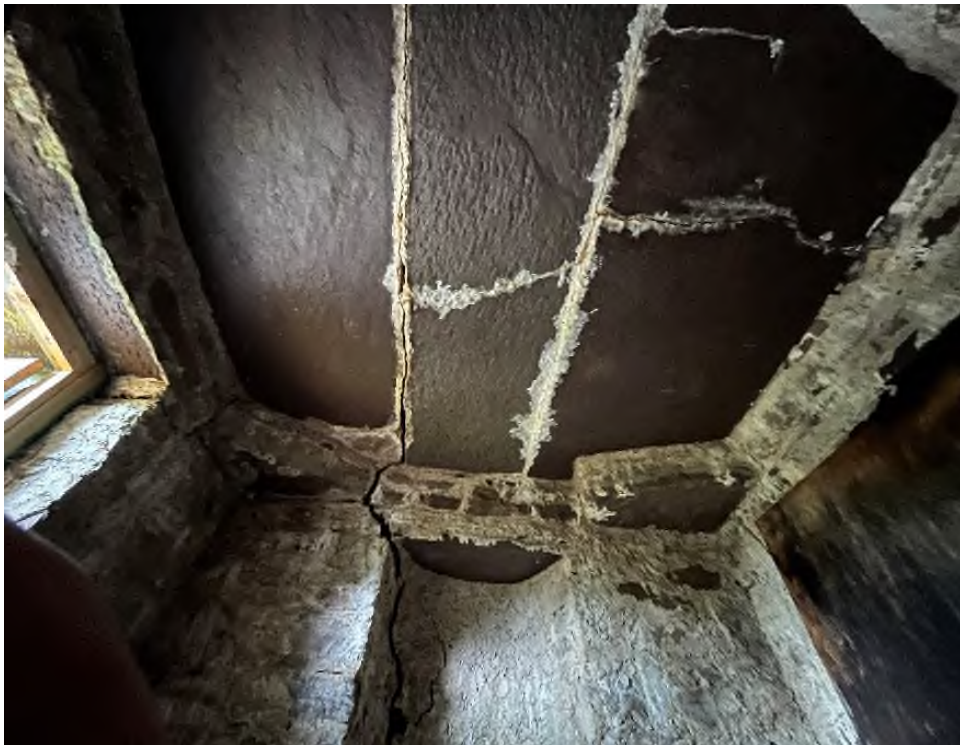
The ceiling comprises three large stone slabs spanning east-west between the external walls. The ceiling slabs rest on a course of large stone with diagonal stones across the internal corners. Two of the three slabs have cracked at midspan. There are lime deposits at the joints between the slabs, at the cracks and on the wall faces. The southernmost joint between the ceiling stones has widened due to movement in the external walls.

*Stone slabs forming ceiling (note lateral cracks marked by lime deposits)*

Provide props to the cracked ceiling slabs from the base of the walls before undertaking any works;

Examine the stone ceiling slabs and, if possible, insert diagonal stitches working from above. The insertion of a steel support may be necessary but will be avoided if possible;

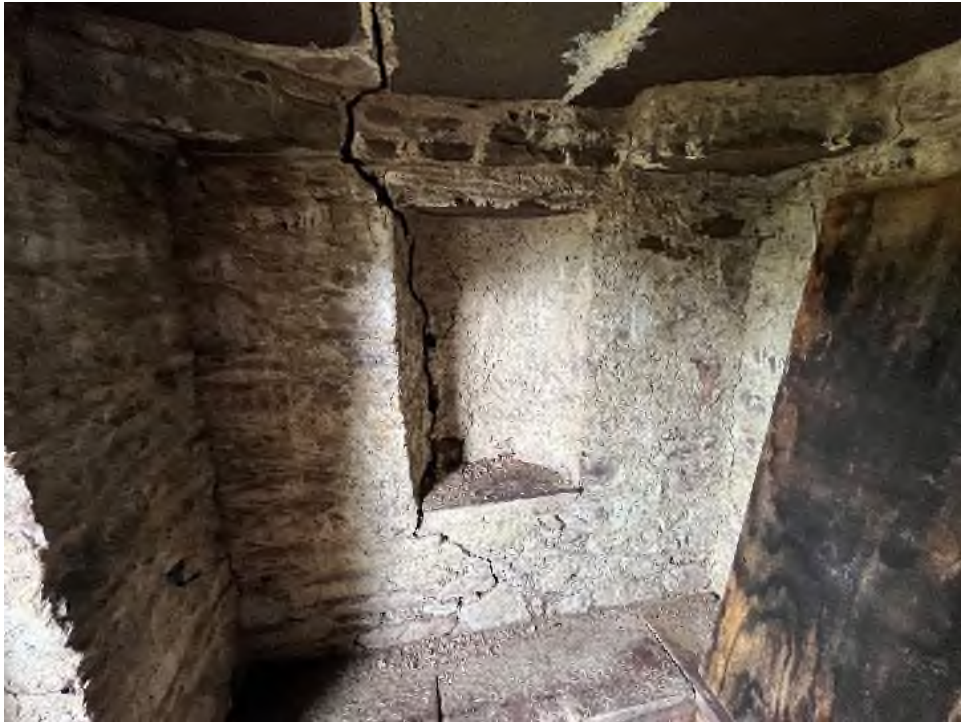
*Western Wall - Inner Face*

The walls comprise roughly coursed sandstone rubble masonry, with cylindrical niches in the north, east and west walls. There are vertical cracks through the niches and at the internal corners.

Pack and stitch the cracks in the walls using stainless steel helical bars, lime mortar and/or grout to reinstate the integrity of the wall;
